# **Report of Marine Survey**

***Marelee***

File Number ..... MARELEE'05  
Date of Survey ..... August 7, 2005  
Requester..... Eric Lee  
Purpose of Survey ..... Underwriting  
Surveyed At ..... Port San Luis, CA  
While the Vessel Was ..... Dry docked  
In Attendance ..... Eric, Sue and Ryan Lee  
Owner ..... Robert Eric Lee  
Flag ..... United States of America  
Vessel's Name ..... MARELEE (ex-MUMBOJUMBO) (ex-BLUE SAILBOAT)  
Hailing Port ..... St. David, AZ  
Official Number ..... CF 6612 FS (California registration – valid)  
Hull Identification Number ..... CFZ6612F0075S  
Service ..... Recreation  
Designer ..... ATKINS  
Builder ..... SPCNS, Somewhere in California  
Year and Model ..... 1979\* ATKINS THISTLE 32  
Type of Vessel ..... Single oil auxiliary masthead cutter  
Accommodations ..... Four

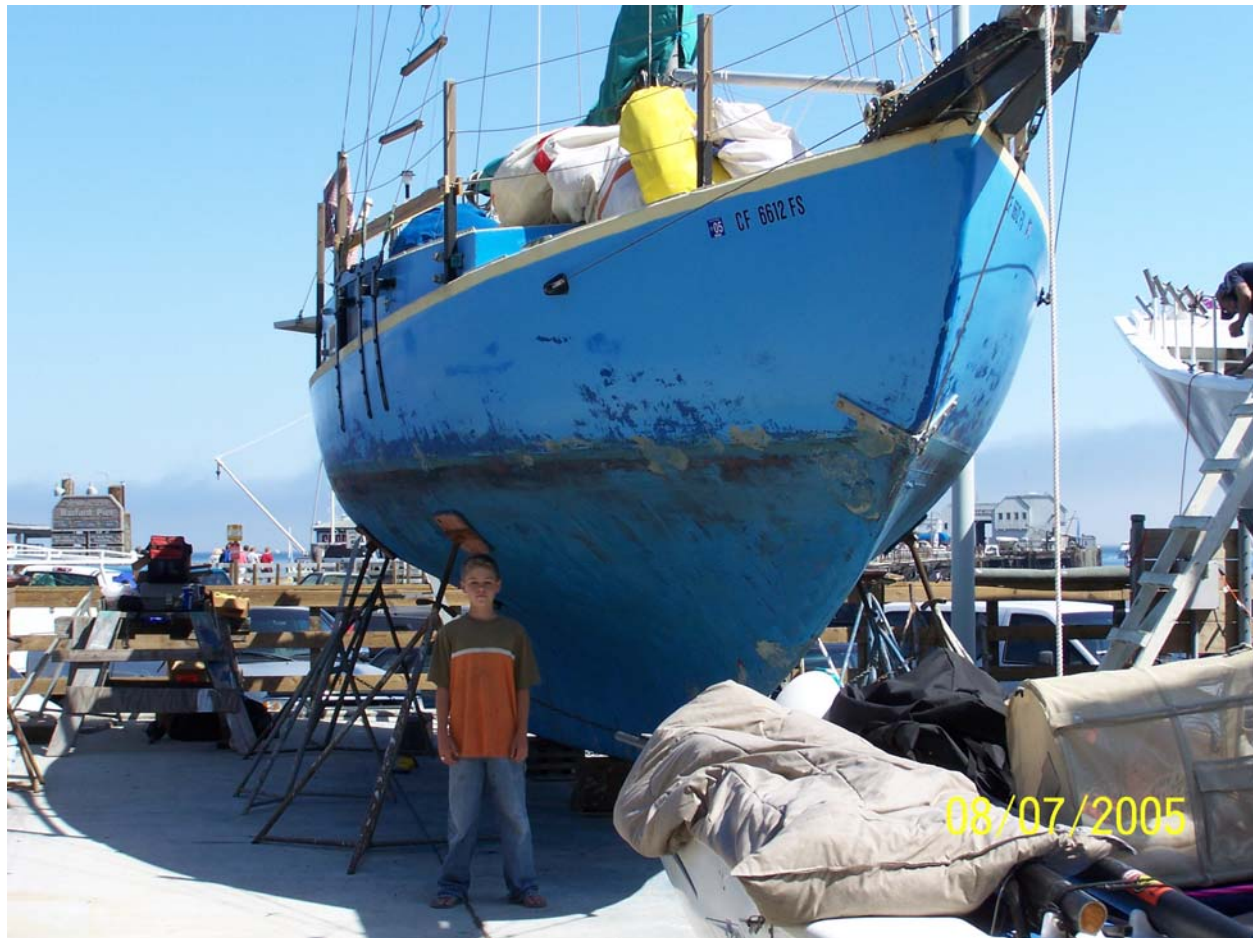
MARELEE sits in dry dock at Port San Luis, California for survey.

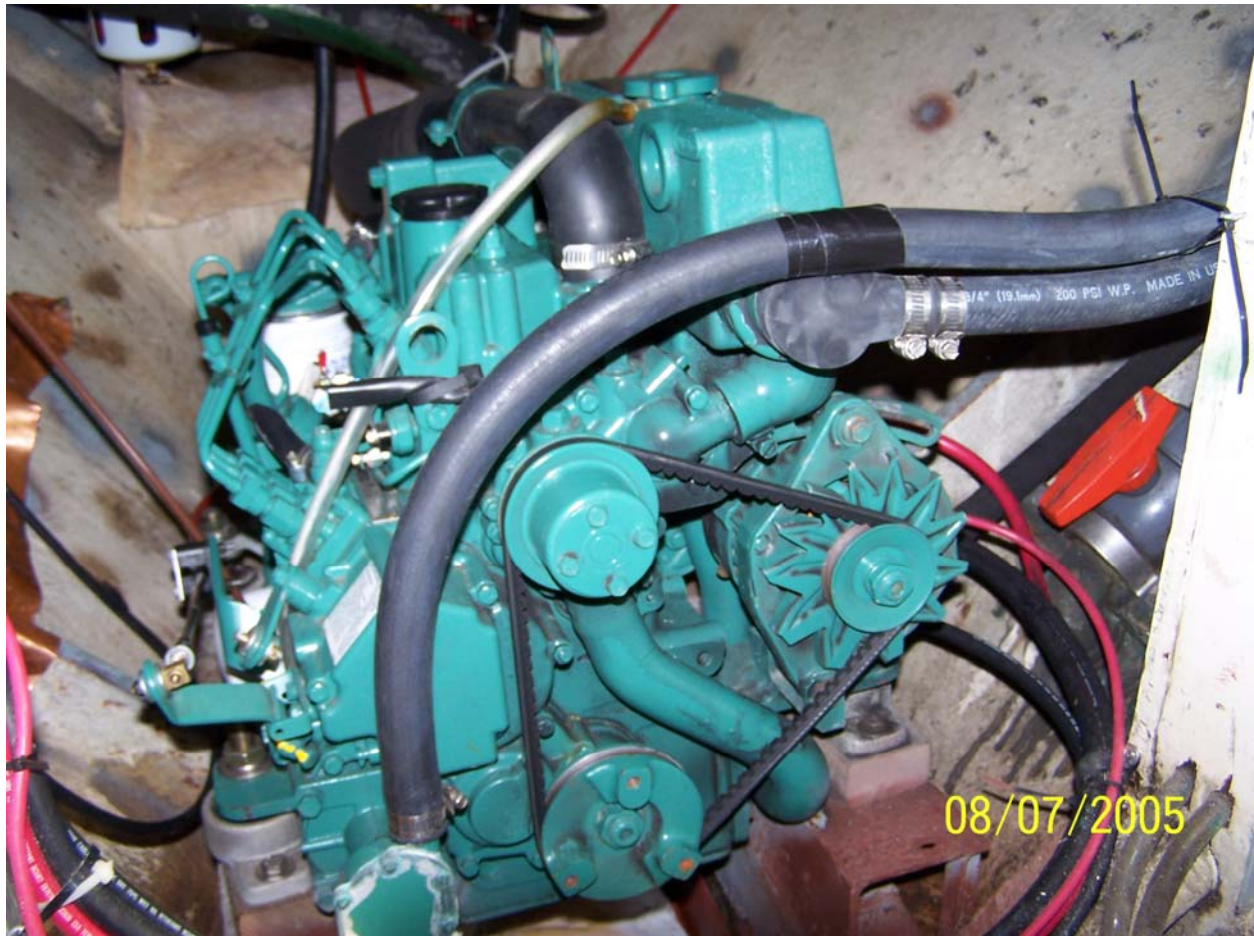
The auxiliary engine is reported to have been installed in 1999. It has almost 1,000 hours of operation registered on the Hobb's meter but the engine appears to be in near new condition. (See photograph as an example following this section.) The engine is well mounted to the foundation and appears to be properly aligned. There is a large vibration dampener between the engine's shaft coupler and the shaft coupler that has increased the length of the shaft aft of the final bearing to too long a section of shaft. The shaft coupler should be replaced with a 1" vibration dampener to rest the propeller in the proper position. The MORSE cable transmission and throttle cables are in near new condition and are well secured in the vessel. The exhaust system appears to be in good condition and no leaks are noted.

A view of the engine in MARELEE showing the high level of maintenance it has received,
